REPORT DOCUMENTATION PAGE		READ INSTRUCTIONS BEFORE COMPLETING FORM
1. REPORT NUMBER	2. GOVT ACCESSION NO. AD-A130646	3. RECIPIENT'S CATALOG NUMBER
4. TITLE (and Subtitle) FOUNDATION REPORT (ON) CONWAY WATER SUPPLY DAM, ARKANSAS		5. TYPE OF REPORT & PERIOD COVERED Final Report, 1980 - '82

FOUNDATION REPORT

June 1983

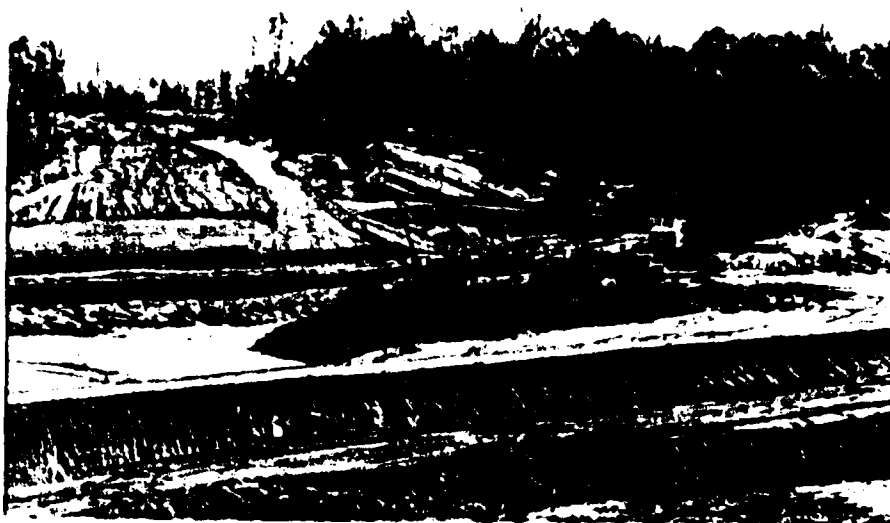
21 Aug 60 Conway Water Supply Photo No. 1

View east showing Phase I excavation and left  
effluent core trench in background.

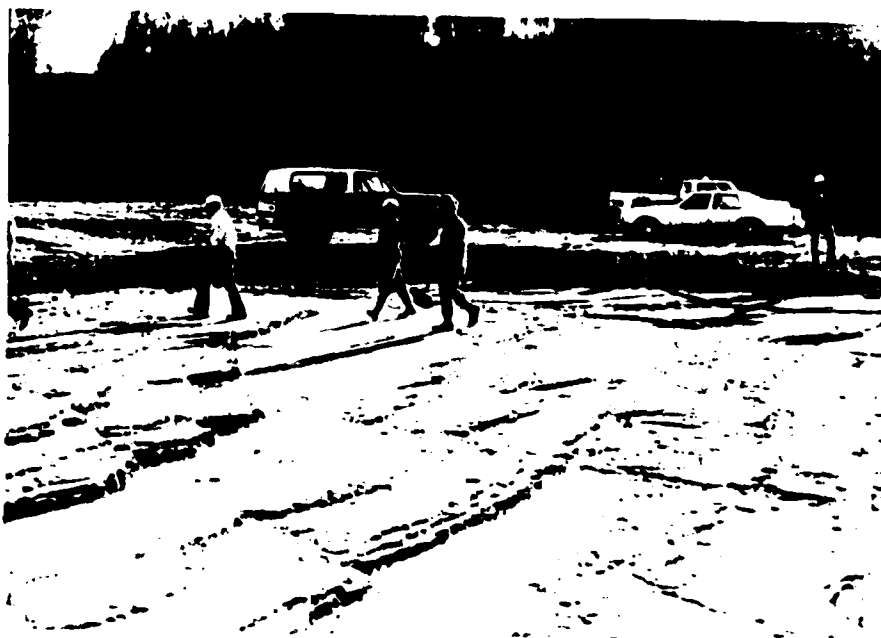
7 Nov 80 Conway Water Supply Photo No. 10

View southwest toward Station 15+20 near pump  
in center-right of photo. Note foundation  
preparation of Atoka Formation.

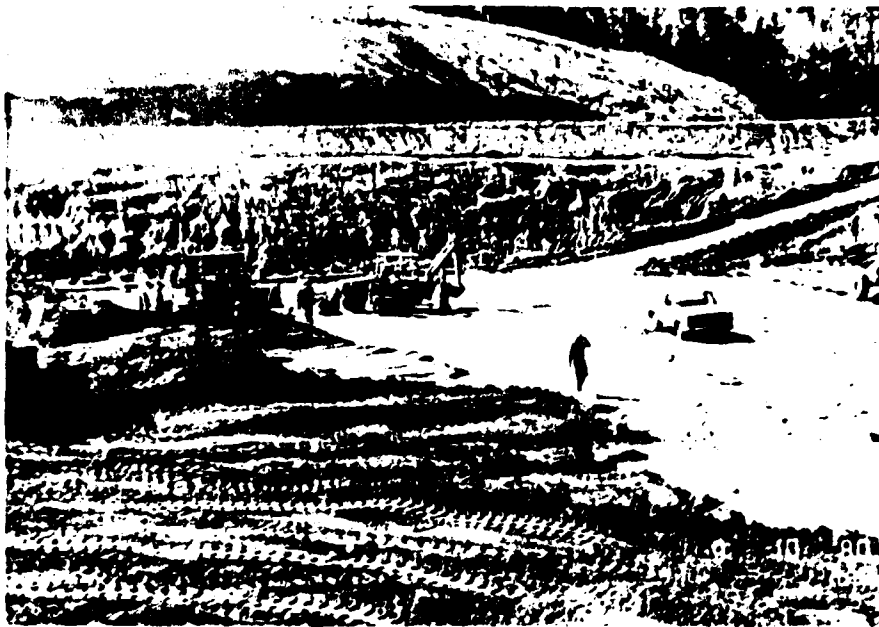
9 Oct 80 Conway Water Supply Photo No. 22

View west showing foundation preparation upstream of dam axis in Phase I excavation. Right abutment in background.

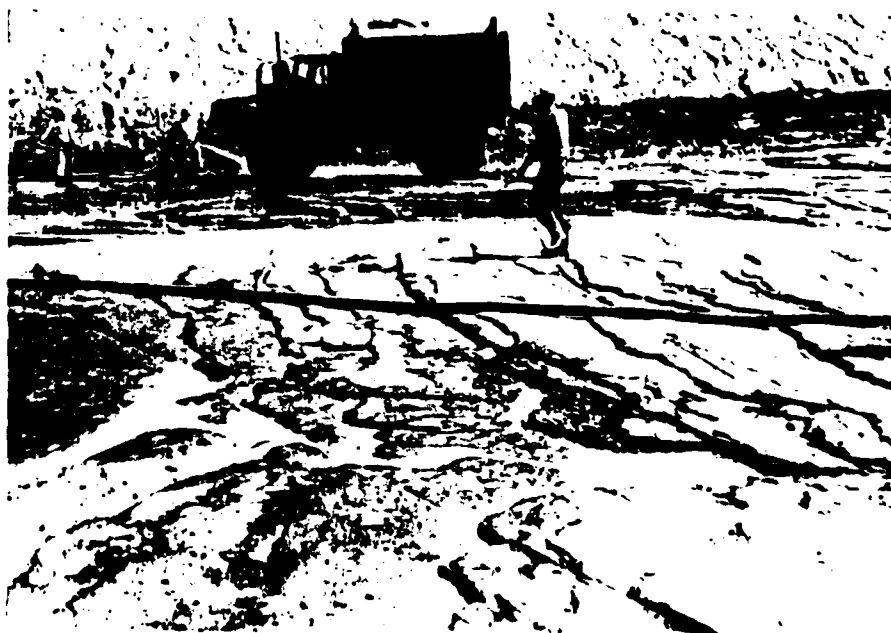
26 Mar 81 Conway Water Supply Photo No. 23

View east showing foundation preparation upstream of dam axis in Phase II excavation.

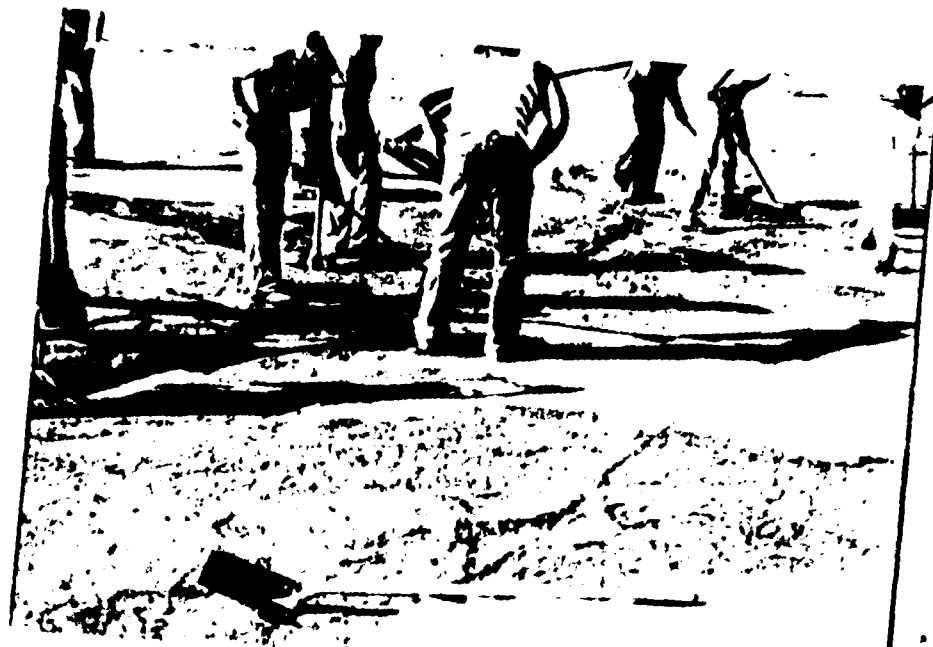
8 Nov 80 Conway Water Supply Photo No. 24

View north showing foundation preparation upstream of dam axis in Phase I excavation.

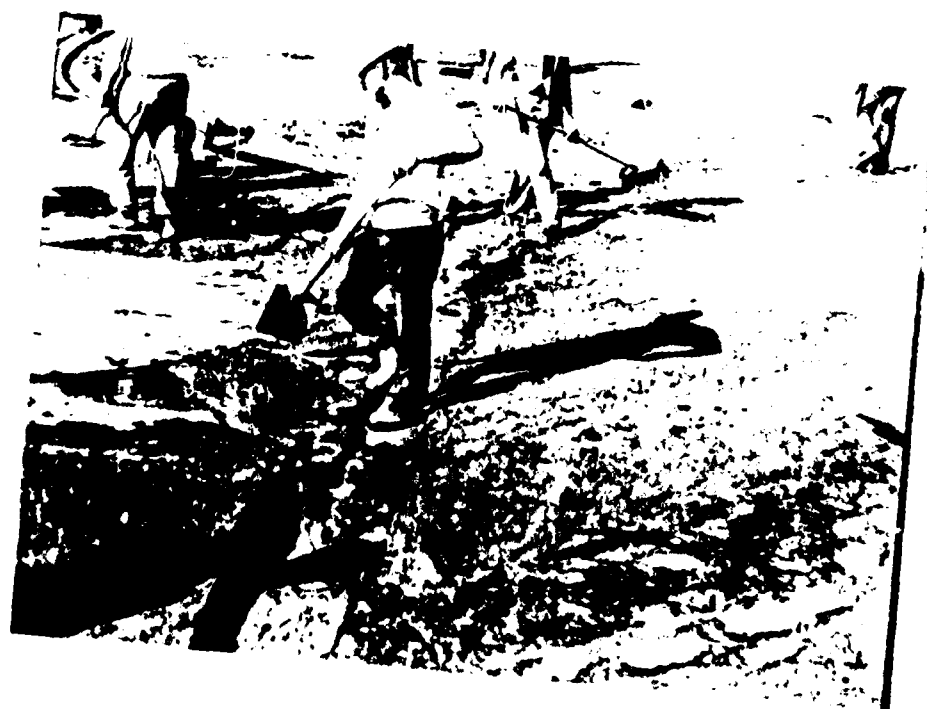
8 Nov 80 Conway Water Supply Photo No. 25

View north showing foundation preparation upstream of dam axis in Phase I excavation.

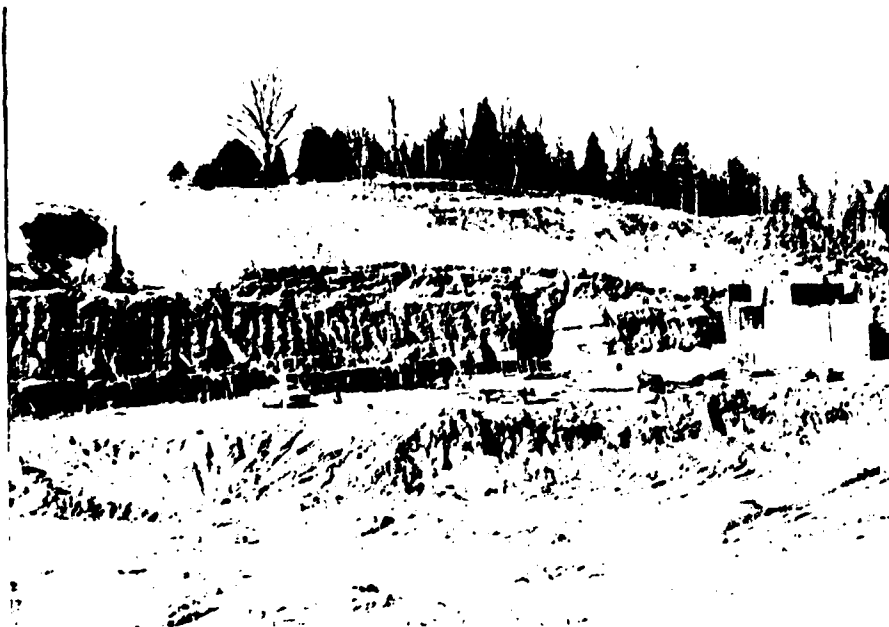
20 Sep 81 Conway Water Supply Photo No. 23

View west toward right dam abutment. Note intake structure and outlet conduit construction in center-right photo, grout hole drilling in core trench in center-left photo, and joints along rock face.

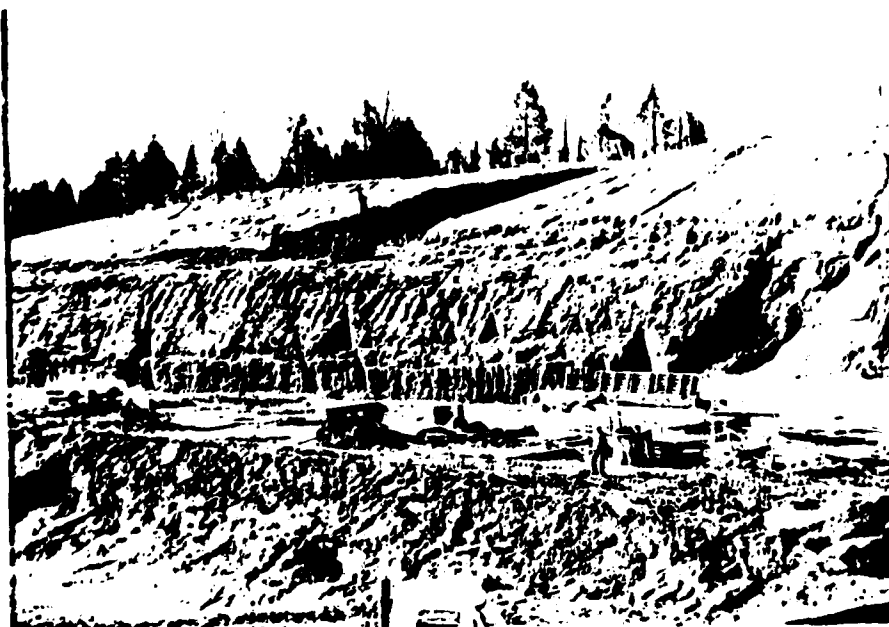
20 Sep 81 Conway Water Supply Photo No. 29

View southwest showing grout hole drilling in right abutment core trench at upper-center photo. Note joints and landslide scar in center-right photo.

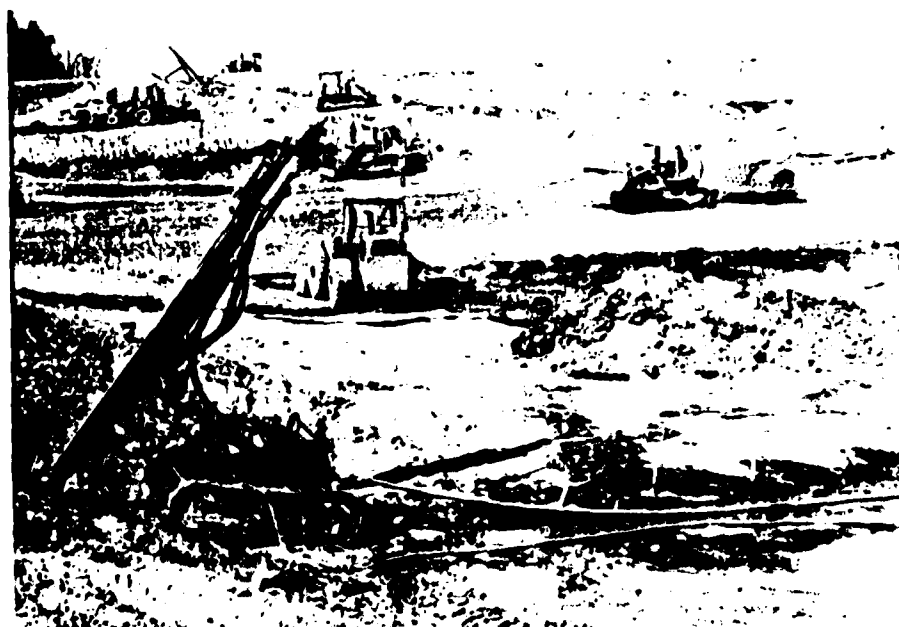
10 Mar 81 Conway Water Supply Photo No. 31

View north showing grout hole drilling rig at about Station 12+00 on the dam axis.

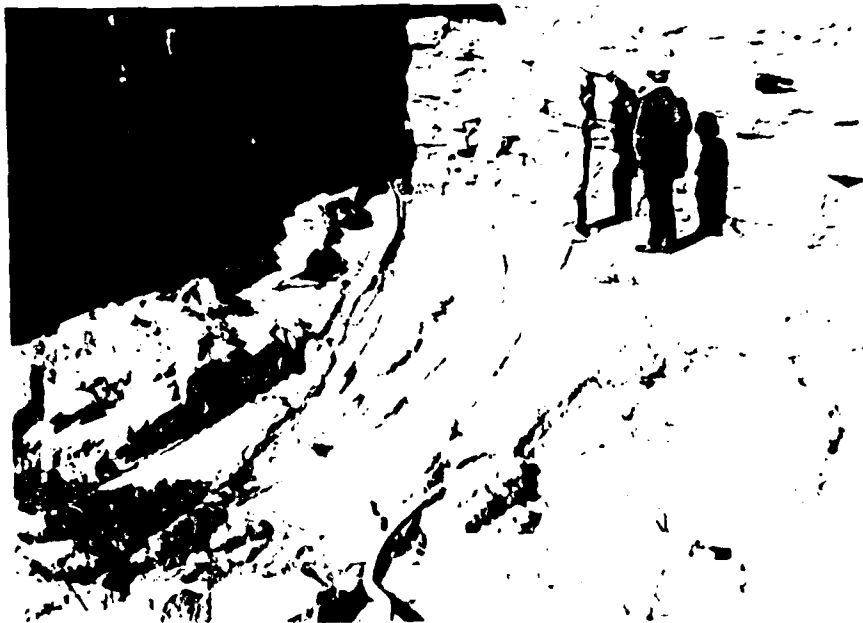
13 Nov 80 Conway Water Supply Photo No. 38

View northwest showing foundation rock exposed  
in intake structure excavation --- Atoka  
Shale.

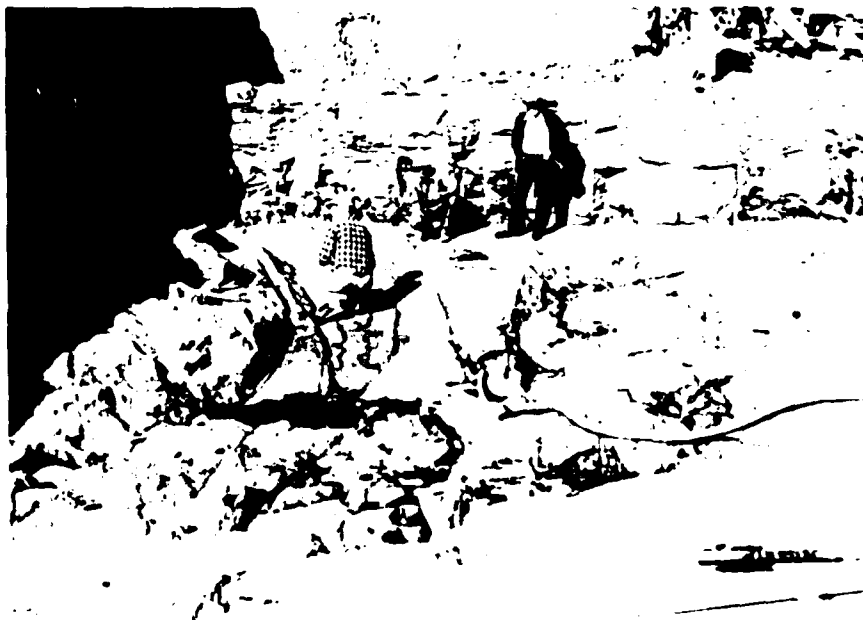
13 Nov Conway Water Supply Photo No. 39

View northwest showing foundation rock ex-  
posed in intake structure excavation --- Atoka  
Shale.

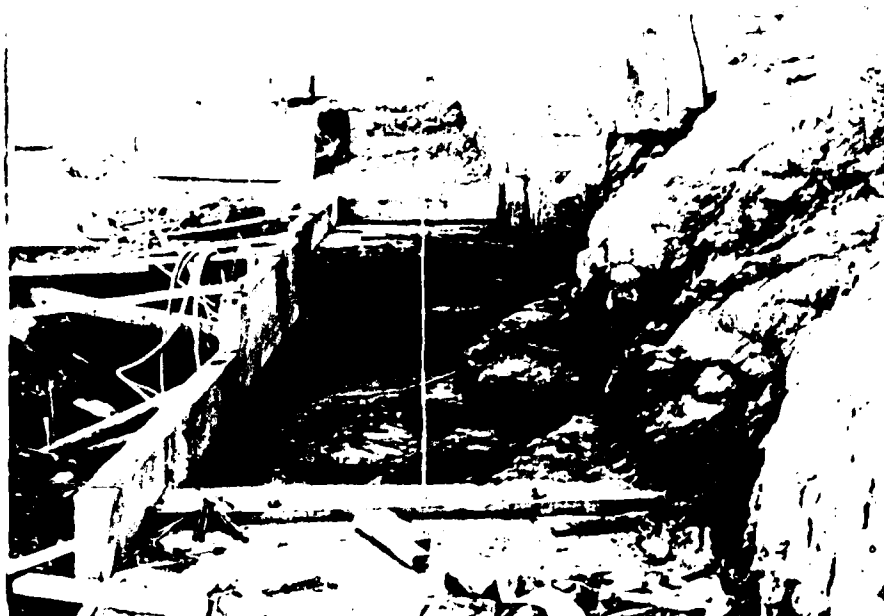
31 Dec 80 Conway Water Supply Photo No. 43

View southeast along outlet conduit alignment  
showing exposed foundation rock from Station  
8+57 --- Atoka Shale.

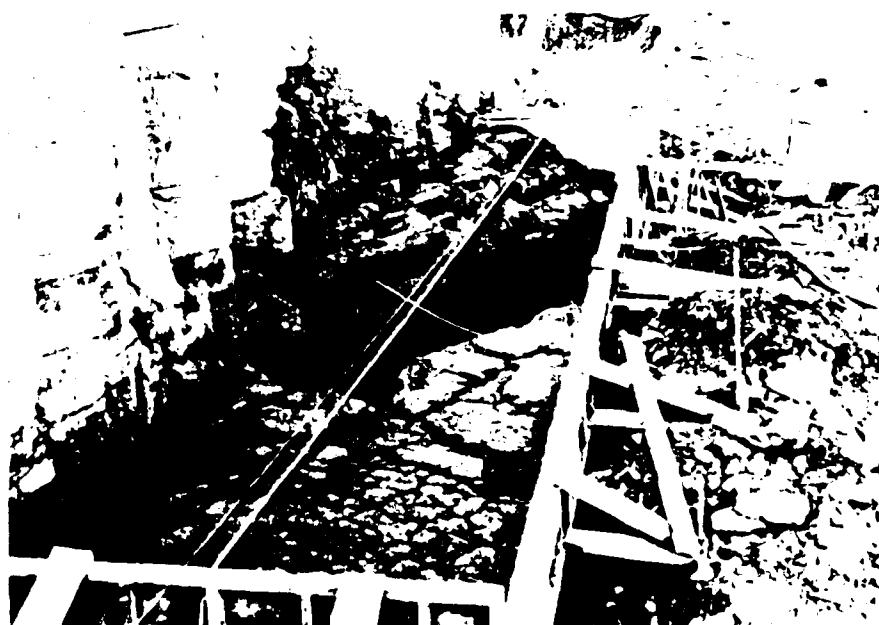
31 Dec 80 Conway Water Supply Photo No. 44

View northwest along outlet conduit alignment  
showing exposed foundation rock from Station  
8+97 --- Atoka Shale.

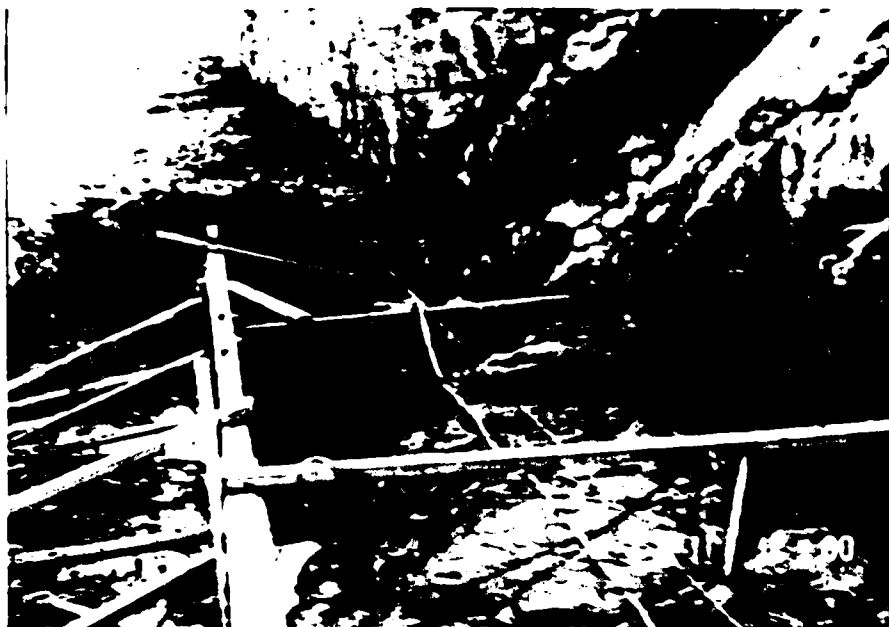
11 Dec 80 Conway Water Supply Photo No. 45

View southeast along outlet conduit alignment  
showing exposed foundation rock from Station  
3+41 --- Atoka Shale.

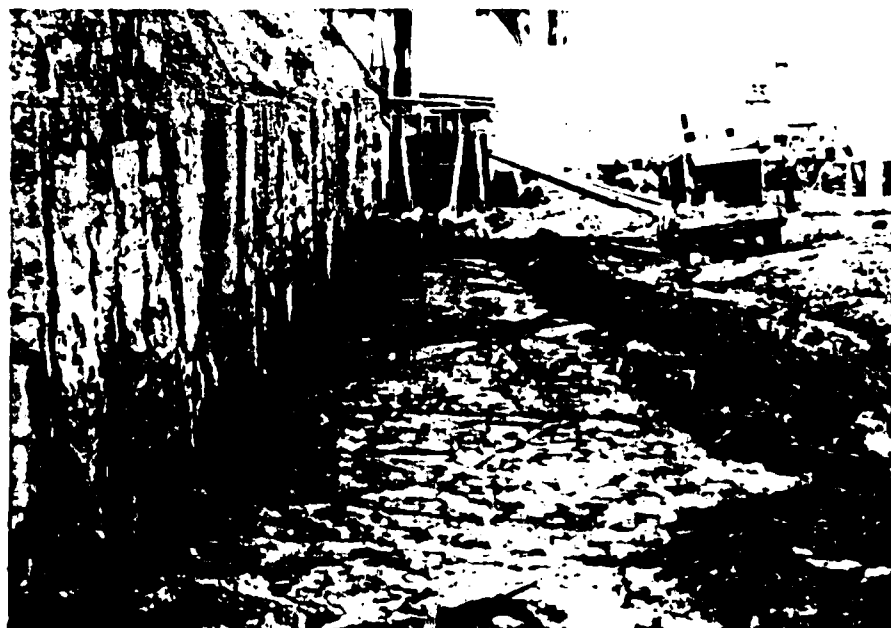
10 Mar 81 Conway Water Supply Photo No. 46

View northwest along outlet conduit alignment  
showing exposed foundation rock from Station  
9+60 --- Atoka Shale.

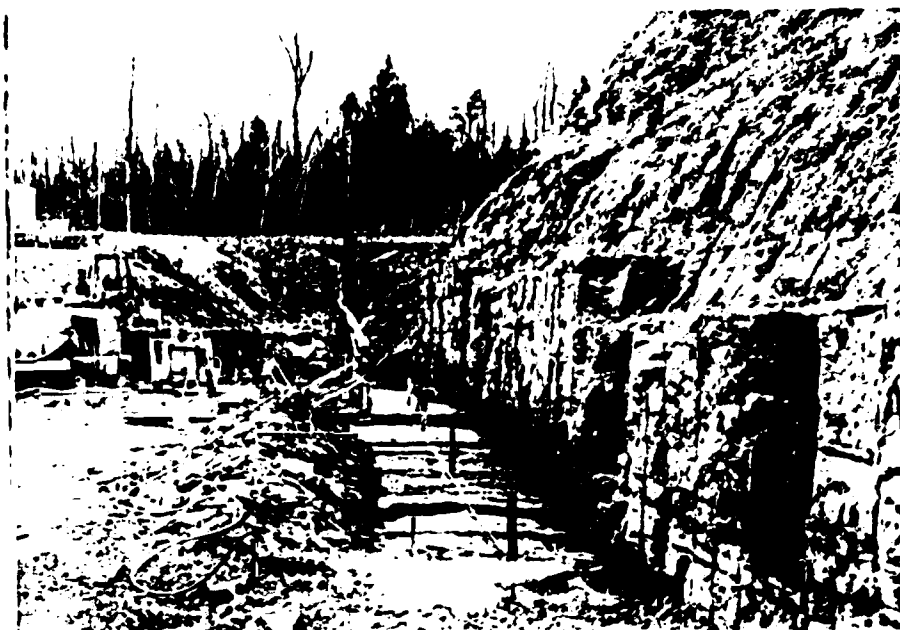
25 Jan 81 Conway Water Supply Photo No. 53

View southeast along outlet conduit alignment  
showing exposed foundation rock from Station  
11+17 — Atoka Shale.

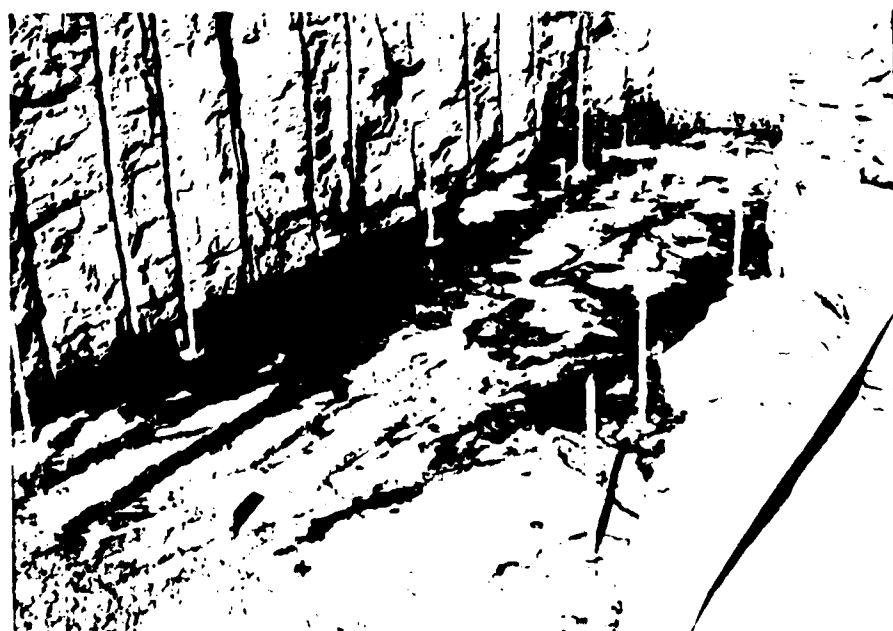
13 Feb 81 Conway Water Supply Photo No. 56

View northwest at upstream stilling basin foundation from Stations 12+16.75 to 12+42.75 --- Atoka Shale.

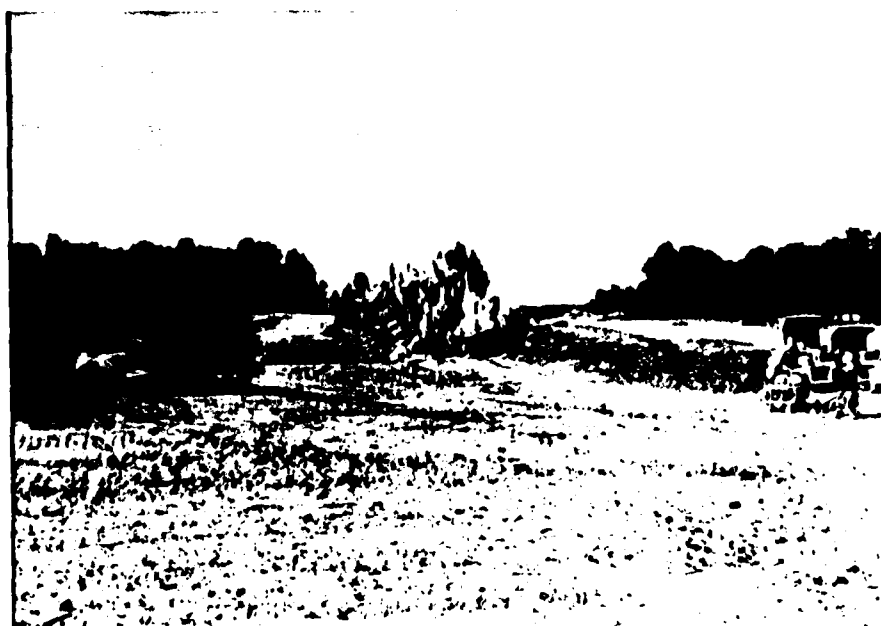
29 Apr 81 Conway Water Supply Photo No. 58

View north at blasting in spillway exca-  
vation.

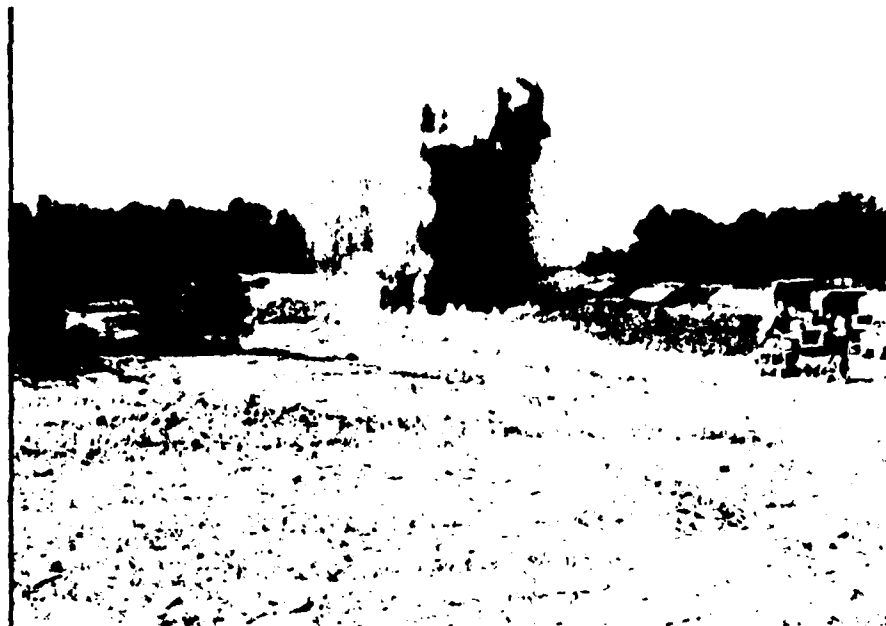
29 Apr 81 Conway Water Supply Photo No. 59

View north at blasting in spillway excavation.

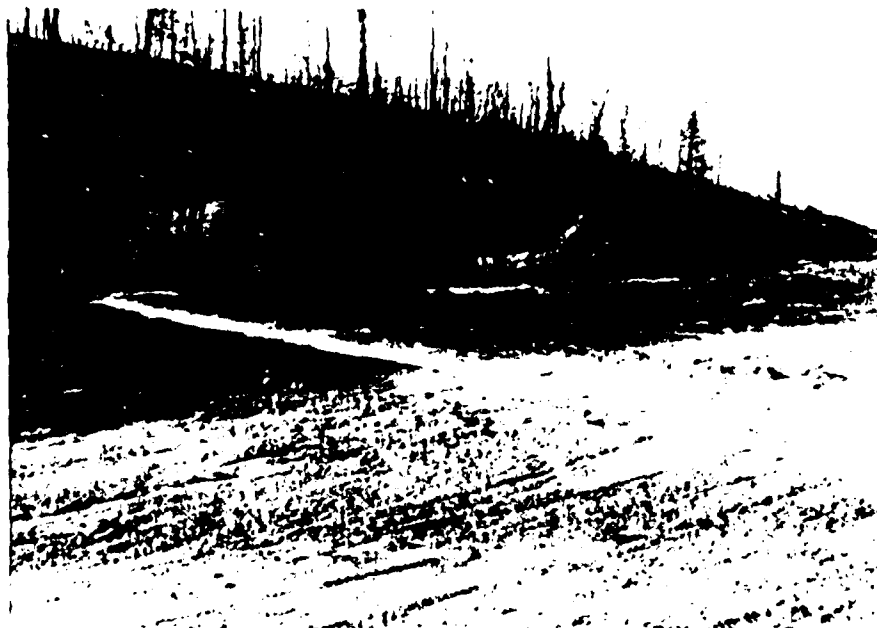
SPILLWAY RIGHT CUT SLOPE LOOKING  
UPSTREAM OVER CONCRETE CONTROL  
STRUCTURE PHOTO #60
